LESSONS LEARNED

Excavation Safety

CASE HISTORY

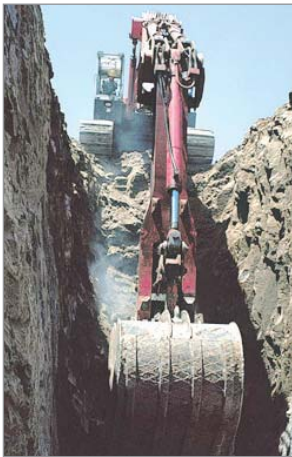
An environmental contractor had a project to install drainage piping at a wastewater treatment plant. A six-foot deep by thirty feet wide trench had been dug for the piping, and an environmental technician was working down in the trench to smooth out gravel bedding at the time of the accident. The trench had been dug horizontally with a backhoe the day before, and the soil was wet and muddy due to recent rain. There was no shoring, trench boxes, or other means of supporting the trench walls. The backhoe used for the job was parked approximately three feet from the edge of the trench.

As the technician was raking gravel within the trench a sidewall suddenly collapsed dropping the backhoe directly on top of him. The weight of the equipment caused a serious leg fracture and other internal injuries. Fortunately, he was wearing his hardhat and did not sustain serious head injuries. Since he was working alone in the trench at the time of the accident, he was not discovered until his supervisor arrived at the accident scene approximately twenty minutes later and heard him yelling for help. The supervisor called for emergency assistance and used a mobile crane to lift the backhoe off of the injured employee. He was then transported to a nearby hospital for emergency treatment. He was sub-

- The trench was not properly secured through shoring, trench boxes, or other means of protecting against a cave-in. Since the trench was over five feet deep, the contractor was in violation of OSHA Standard 1926.651 and could have been cited for willful lack of compliance. Refer to the OSHA website at: <http://www.osha.gov/> for more information on the OSHA Excavation Standard.
- The heavy equipment that injured the employee should not have been parked close to the edge of the trench; the weight placed additional stress on the unsupported soil.

- The use of pre-fabricated trench boxes became mandatory for all work involving entering trenches deeper than five feet or where the likelihood of collapse was possible due to steep sloping, water intrusion, loose soil composition, or other factors.
- Employees working onsite were required to work in two-man teams when entering trenches or other potentially hazardous work environments.
- Employees and supervisors were provided with a review of emergency procedures to follow in the event of an accident/incident.
